Insulated Wall? *(nearly)*

In theory this wall meets building regulations

In practice there's a flaw the inspector won't see, why?

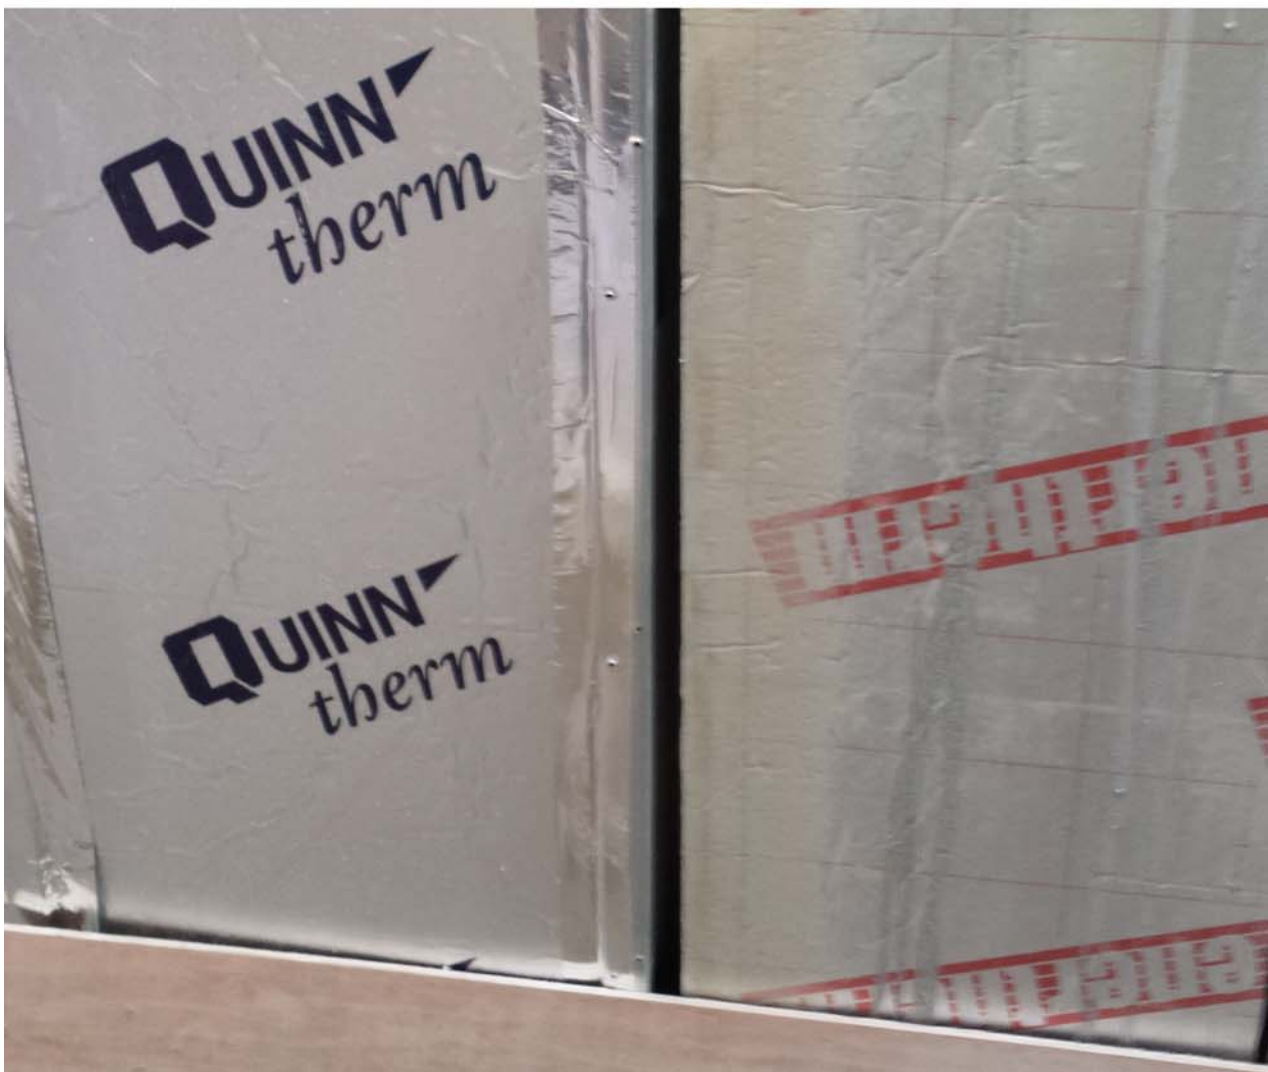
This picture shows an uninsulated solid wall with a steel frame in front of it, then 70mm PIR insulation panels fixed between the uprights. 70mm PIR on a solid wall provides the regulation U-value so what's the problem?

The obvious problem is the gap between the steel profile and the insulation, not yet hidden by sticky tape. Condensation forms when warm air hits a cold surface, so without ventilation in this slot mould will eventually form.

The less obvious problem is the steel frame itself, hidden behind the sticky tape below. The 'C' shape profile means the 50mm wide frame is hollow and therefore uninsulated too. Ideally the PIR board should be pushed into it to provide continuous insulation of the wall. But this is difficult, so while it should happen it rarely does happen. Even with another length of tape to seal the obvious gap, There's still a 50mm cold strip every 400 or 600mm.

What's needed here is a vapour resistant, high performance insulating foam, ideally adhered to the wall itself to eliminate the void and tightly packed to fill the frame too. Solarcrest recommend BASF Walltite spray foam.
