Designed by Engineers *(but not installed by engineers)*

In theory this roof achieves a very low u-value

In practice it's a potential disaster waiting to happen, why?

Solarcrest
COMPLETE ECO-RETROFIT

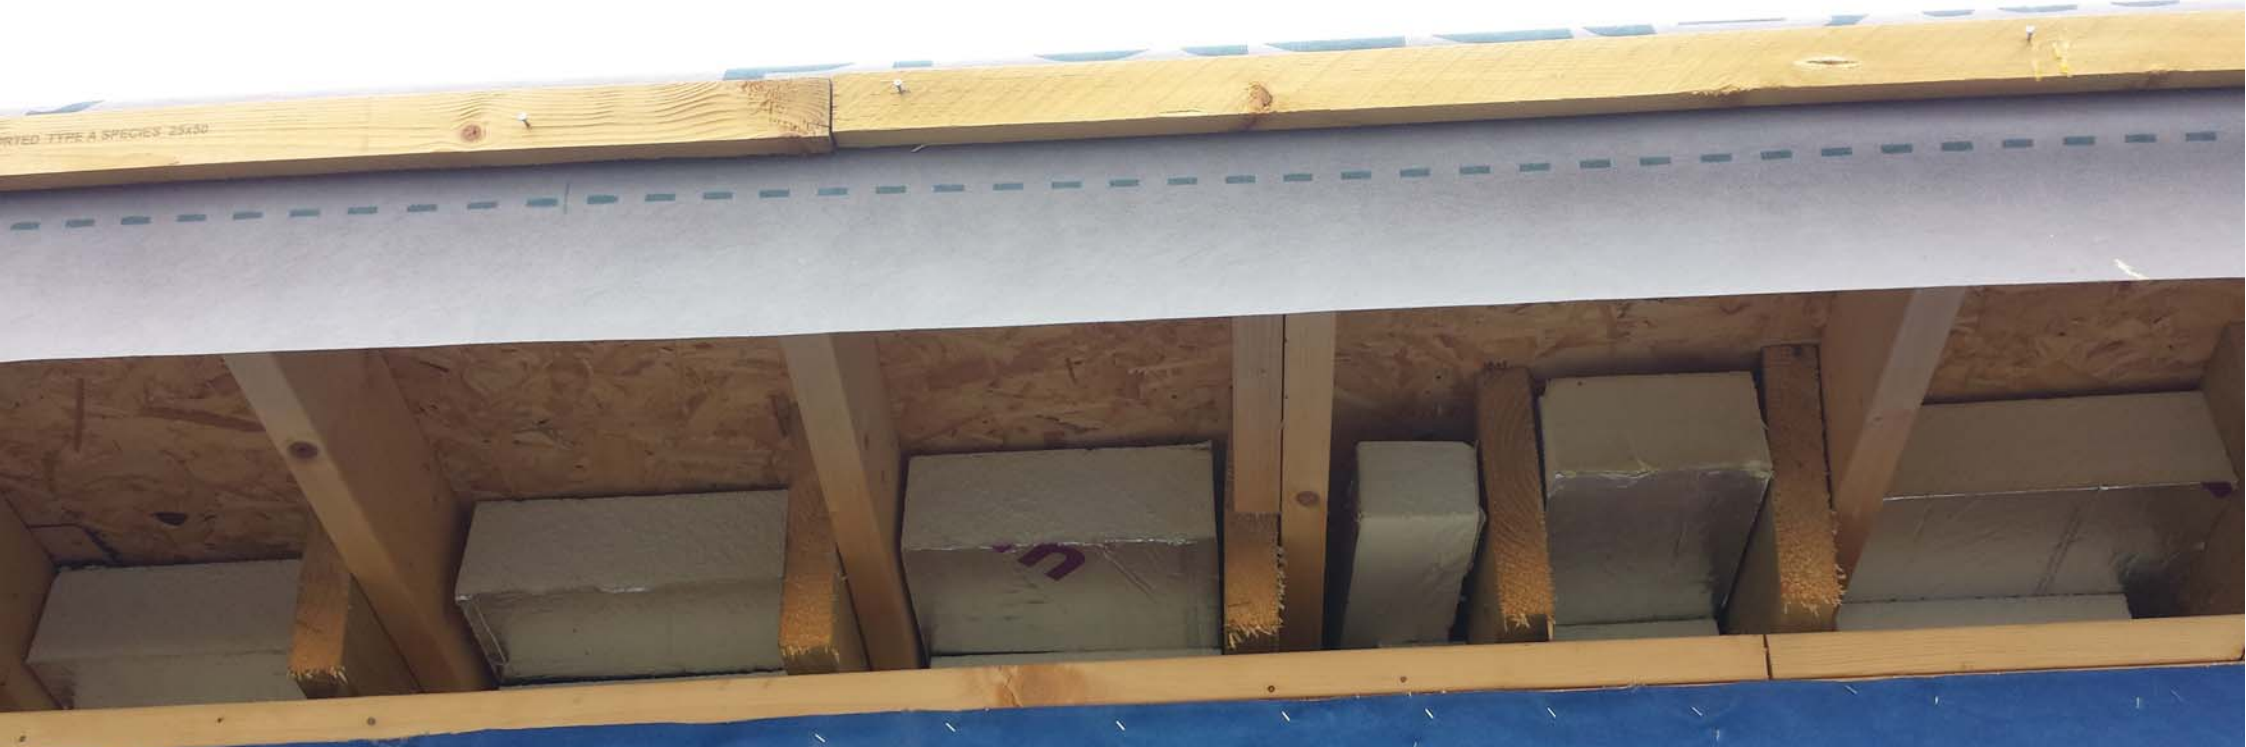
Warm, damp air can squeeze through a gap less than 1mm wide, so no problems squeezing through these gaps (which will soon be hidden from view). Condensation forms when the warm, moisture laden air hits a cold surface, in this case the OSB board above the insulation. In this roof the space between the insulation and the OSB board is unvented, so when the moisture builds up it'll begin to rot the OSB boards, which eventually will affect the rafters too. The heating and cooling of the OSB boards during the summer will aggravate the problem rather than alleviating it. What's needed here is a breathable, hygrophobic (moisture repelling), flexible foam insulation, tightly packed to fill the whole void space, to eliminate the gaps and the space below the cold surface..
